Adeyfield Free Church

**Adeyfield Free Church
Leverstock Green Road
Hemel Hempstead, Hertfordshire
HP1 2BT**

Bat Survey

January 2013

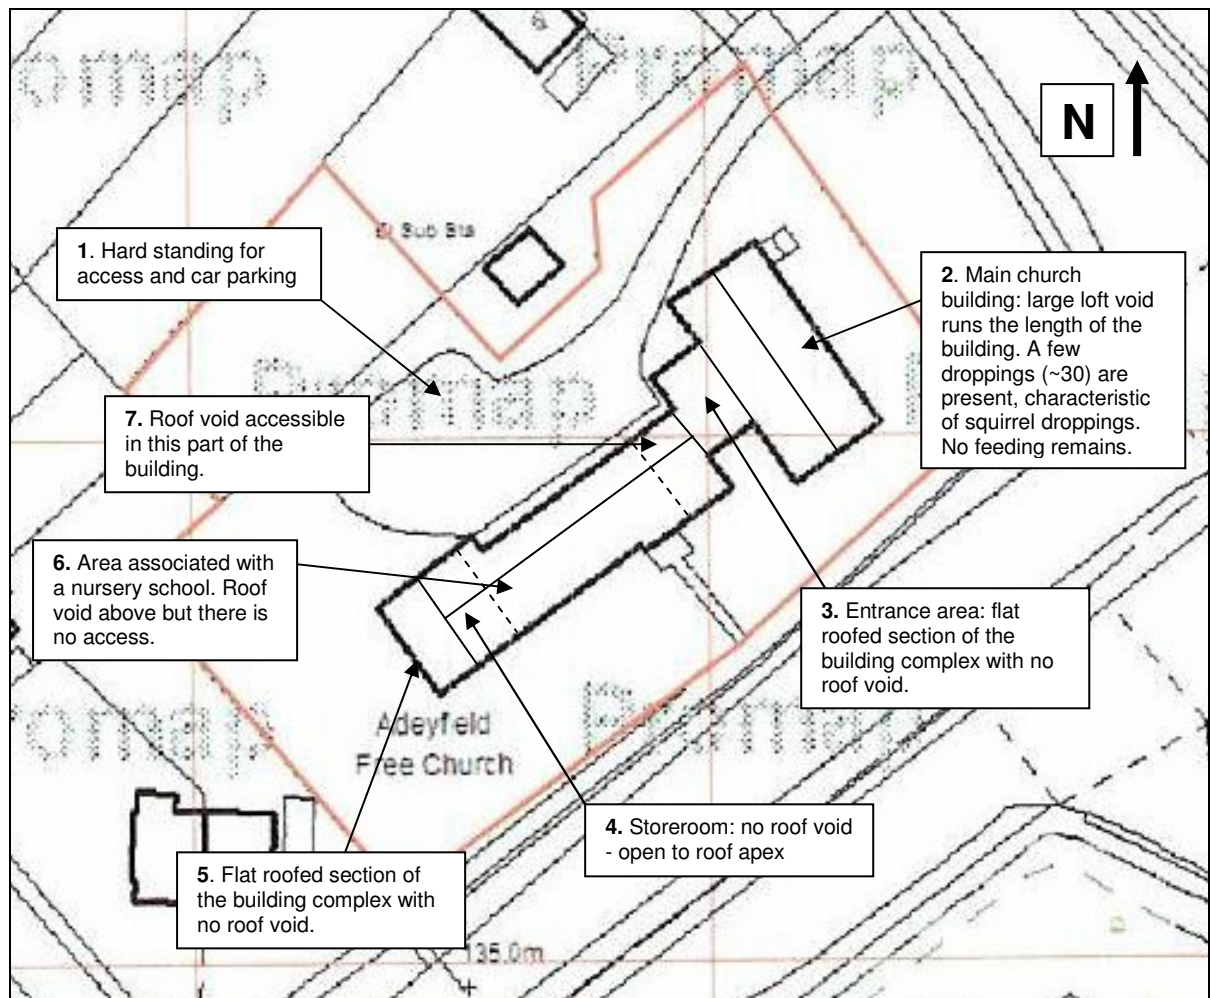
Figure 2 Survey results

Close inspection of the roof areas could be gained from two areas of flat roofs, which are located at either end of the nursery school building (Figure 2, Areas 3 & 5). As a result this made possible the ability to closely inspect the roof areas and subsequently provide a high degree of confidence that the buildings supported limited opportunities for bats to roost.

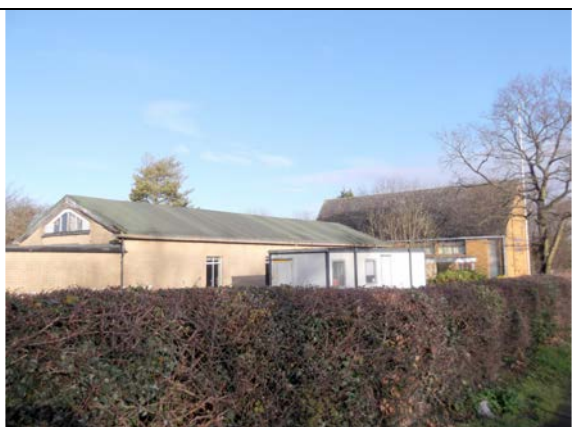
Photograph 1

<p>Adeyfield Free Church</p> <p>The church buildings comprise the tallest section which is used for the church services (shown to the right in the photograph) and various lower sections, the main parts of which are presently used as a nursery school.</p>
---	---

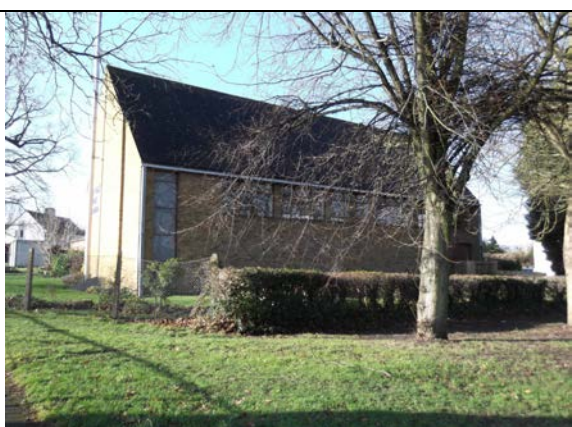
Photograph 2

<p>Main Church Building</p> <p>This tallest section of the building has a large loft space of trussed construction, which is accessed internally via a ladder in the southern corner of the building.</p>
--	--

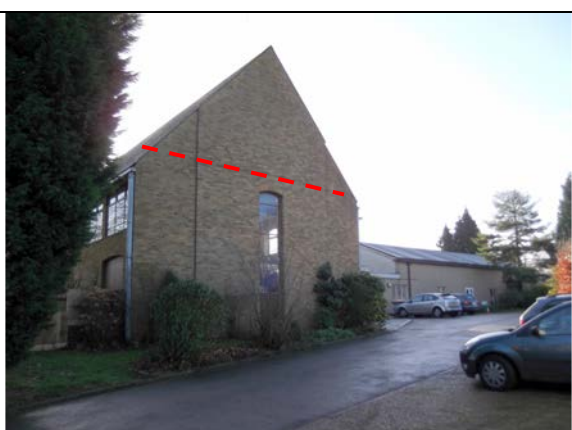
Photograph 3

<p>Main Church Building / Access road to rear</p> <p>The red dotted line illustrates the approximate location of the ceiling, with the large loft void above, which extends to the ridge apex.</p>
---	---

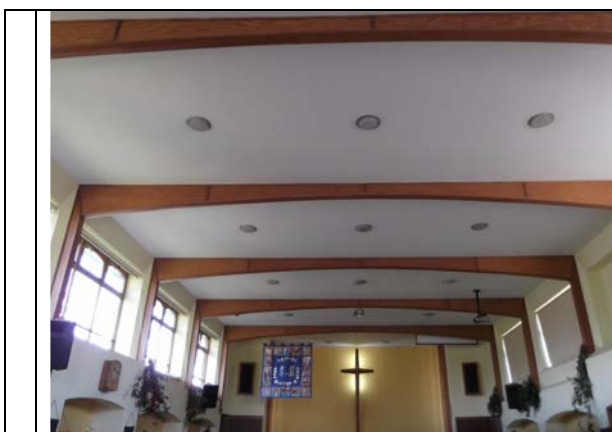
Photograph 4

The ground floor of the main church building comprises a single large room with a raised dais at the south-eastern end (Photograph 4). Entry to the loft above was facilitated by a ladder installed behind a screen in the southern corner of the room. The ground floor provided no evidence of use by bats. Similarly,

**Main Church Building interior**

The interior of the building was searched for evidence of bats, especially droppings. Although churches are cleaned evidence may sometimes be found by viewing areas which are difficult to access and clean (e.g., walls, high window sills). No evidence of use by bats was observed.

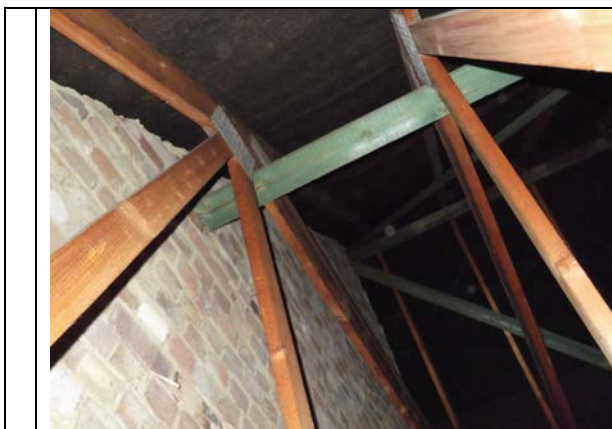
Photograph 5

**Loft space of main building**

The photograph shows the large loft interior at a gable end. The entire loft was searched from end to end, looking for signs of bats or use by bats. None was observed.

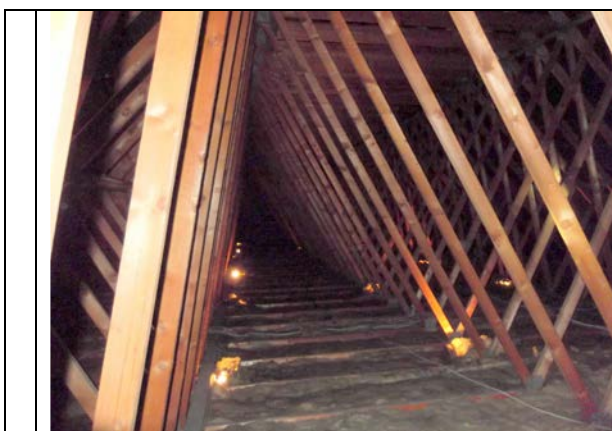
Photograph 6

**Loft space of main church building**

Trussed roof construction, such as used in this building, can inhibit use by certain bat species, due to the cluttered nature of the construction.

However the roof void in this building is sufficiently large that there is potential for adequate flight room for bats, although there was no sign of use.

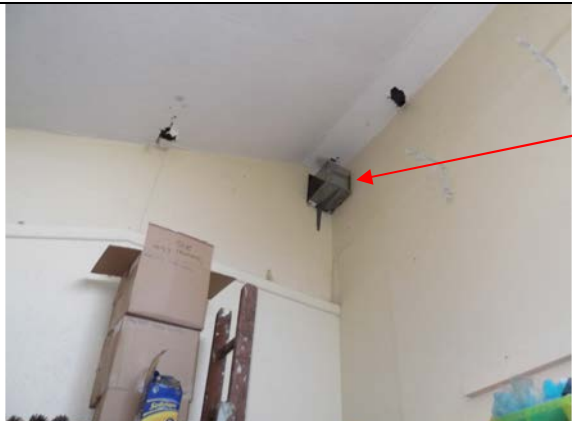
Photograph 7

<p>Storeroom Identified as area 4 on Figure 2.</p> <p>A mammal trap has been installed in a small entrance into the roof void above the nursery with the purpose of capturing and removing squirrels. There have been no recent signs that squirrels are currently using this part of the building after wire netting has been installed at eaves level to prevent squirrel entry.</p>
---	---

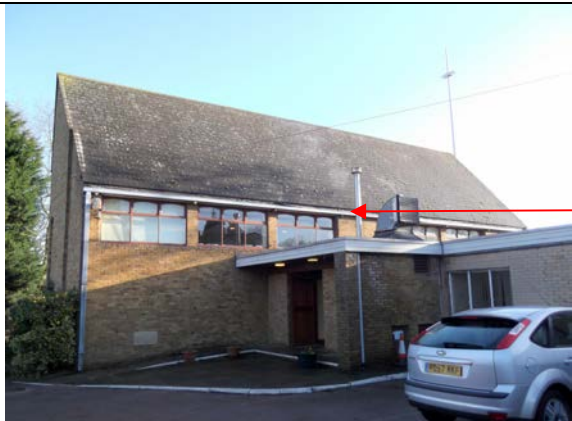
Photograph 8

<p>Main Church Building Identified as area 2 on Figure 2.</p> <p>The location of the gap in the timber facing, as shown in Photograph 11, is arrowed.</p>
--	--

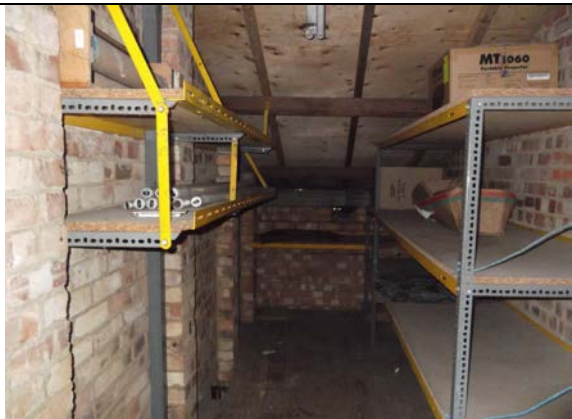
Photograph 9

no other areas showed any evidence for use by bats. Another loft space (Photograph 9) was searched which is located above the passageway that links the nursery school and the church entrance area. This loft has an air brick installed in a gable end wall. It is partly obscured by an old wasps' nest which adheres to the brick.

<p>Roof void Identified as area 7 on Figure 2. A hatchway from the passageway below gives access to a small loft void. There were no signs of bats using this area and no gaps were seen that could provide bat access. Gaps at eaves level had been previously blocked with wire netting to prevent squirrel access. An air brick on the gable end wall had the remains of a wasps nest adhering to the brick, partly obscuring the access.</p>
---	---

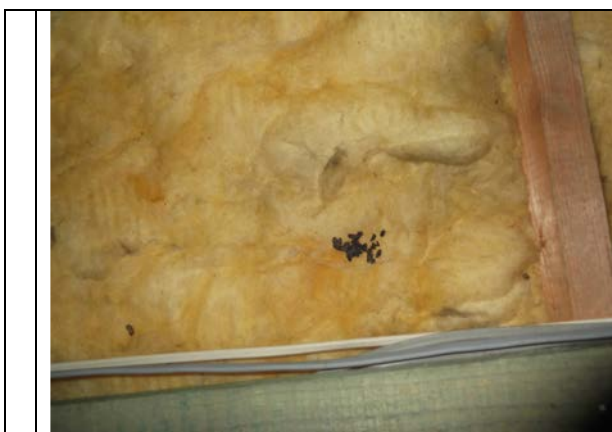
Photograph 10

**Droppings in the loft of the main building**

A few mouse droppings and a number of larger droppings in greater numbers (~ 30 in totals) were found. These larger droppings were found both scattered and also gathered into a small pile.

The larger droppings are likely to belong to the grey squirrel (*Sciurus carolinensis*). A likely entry point is shown in the photograph below.

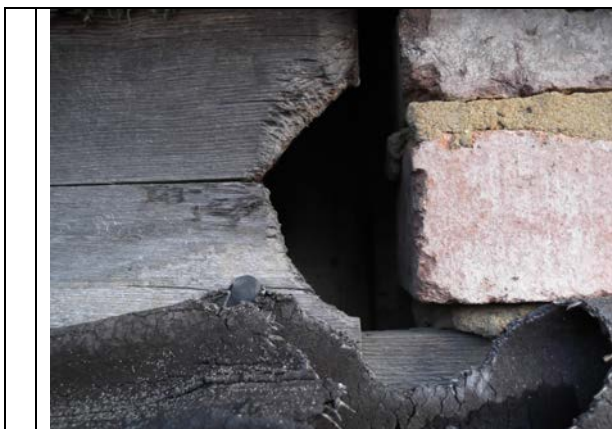
Photograph 11

**Timber facing above gutter (Main Church Building)**

The timber facing shows evidence of being gnawed to enlarge the hole. This is likely to have been caused by squirrels which have historically been entering the church buildings. In the past squirrels have periodically been trapped and removed (Pers. Comm. church warden).

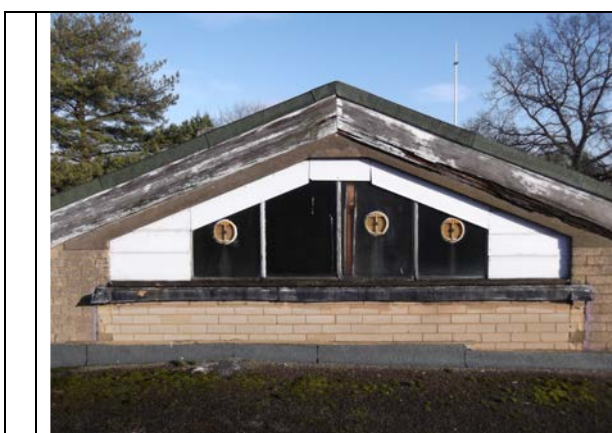
Photograph 12

**Roof section above nursery school**

Identified as area 6 on Figure 2. A nursery school occupies part of the lower single storey buildings attached to the main church building. There is a sealed section of the roof above the nursery school area. Although this area cannot be accessed for survey the eaves and roof line were closely examined and are well sealed (example - see Photograph 13).

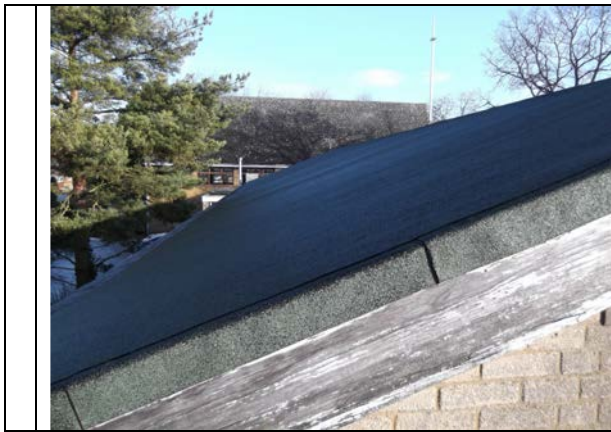
Photograph 13

**Roof covering above the nursery school**

Identified as area 6 on Figure 2.

Bitumastic roofing felt above the nursery is well fitted and sealed, providing no opportunities for access by bats. In the past squirrels have entered the building. Wire netting has now been installed at eaves level to deter squirrels from entry. This will also prevent potential access by bats.

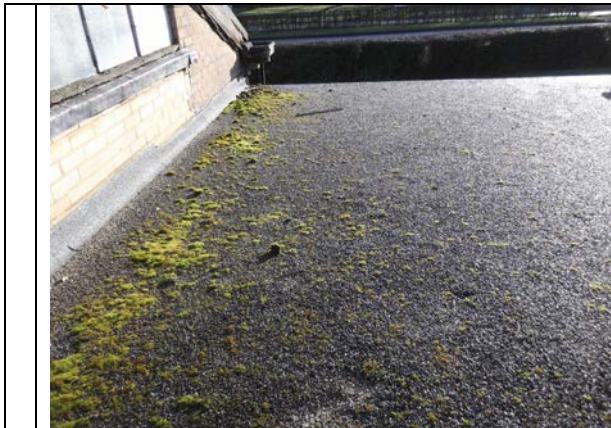
Photograph 14

**Flat roofed area**

Identified as area 5 on Figure 2.

The bitumastic roofing felt is well fitted and sealed, providing no opportunity for bats. No signs of bats were evident.
