2 GLENVIEW ROAD, HEMEL HEMPSTEAD

In accordance with your instructions, AA Environmental Limited (AAe) carried out an ecological survey of the above site on Thursday 17 January 2019. The purpose of the survey was to determine the existence and location of any ecologically valuable areas and to record any evidence of protected species, in particular bats. This information will serve to assess the ecological impact of the proposals and identify any ecological constraints and/or mitigation measures that may be required. A series of photographs has been attached for reference.

Encl. Photograph Record Sheet (Drg. No. 193037/01)

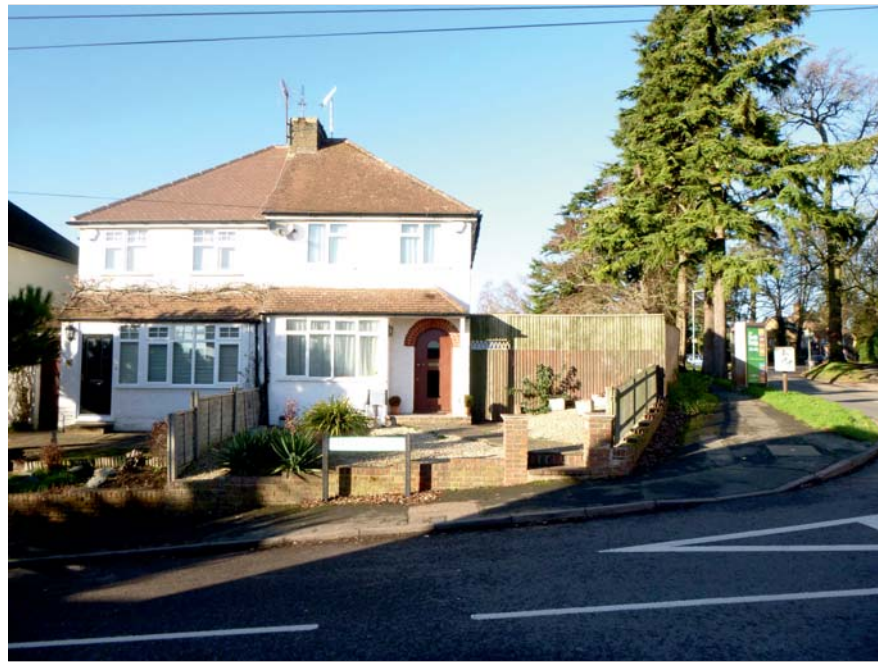
Photograph 1: Showing the front of the property.

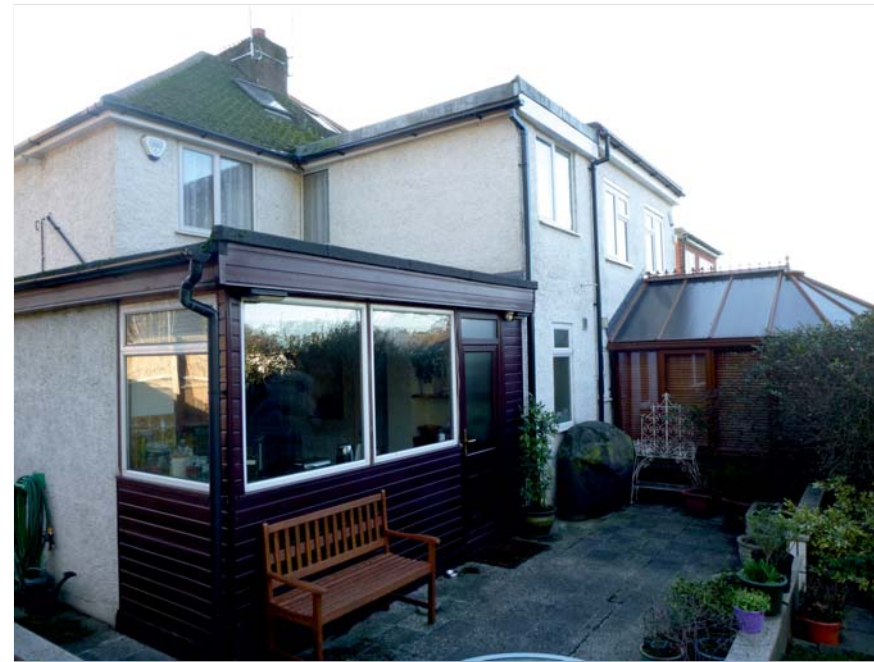
Photograph 2: Showing the rear of the property and patio area.

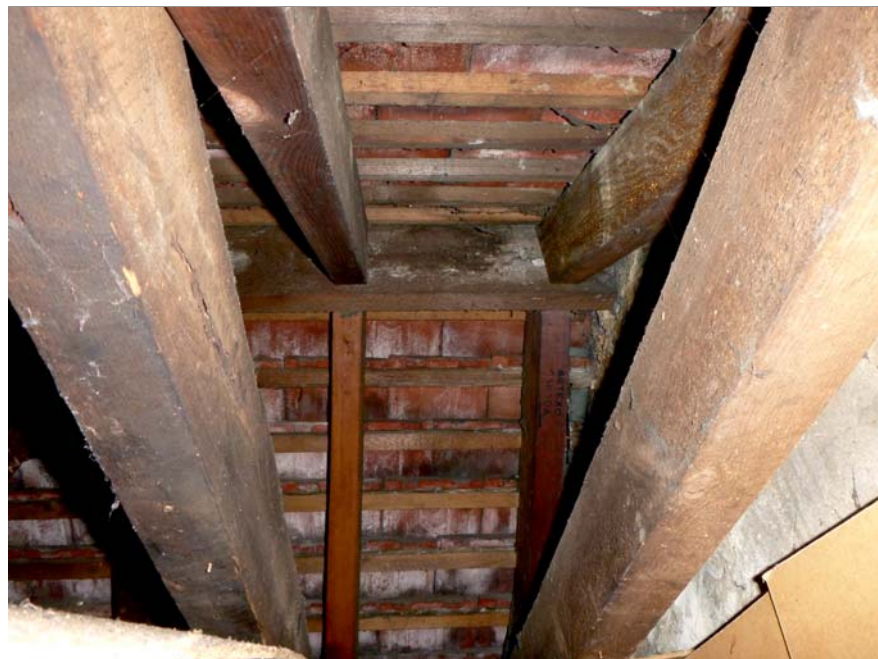
No evidence of bats was recorded during a careful internal and external inspection of any of the buildings on site. The property was well maintained, with no visible gaps in the tiling or soffits/fascias. The converted attic space was well-lit by the Velux window and was unlined, with the undersides of the roof tiles visible behind the chipboard cladding. The garage was also well maintained and sealed, lacking any obvious access points or crevice dwelling features that bat could utilise for roosting, with any narrow gaps behind barge boards filled with general debris and cobwebs. The timber garden shed did not provide any roosting opportunities for bats.

Photograph 3: Showing the unlined attic space, exposing the undersides of the roof tiles.

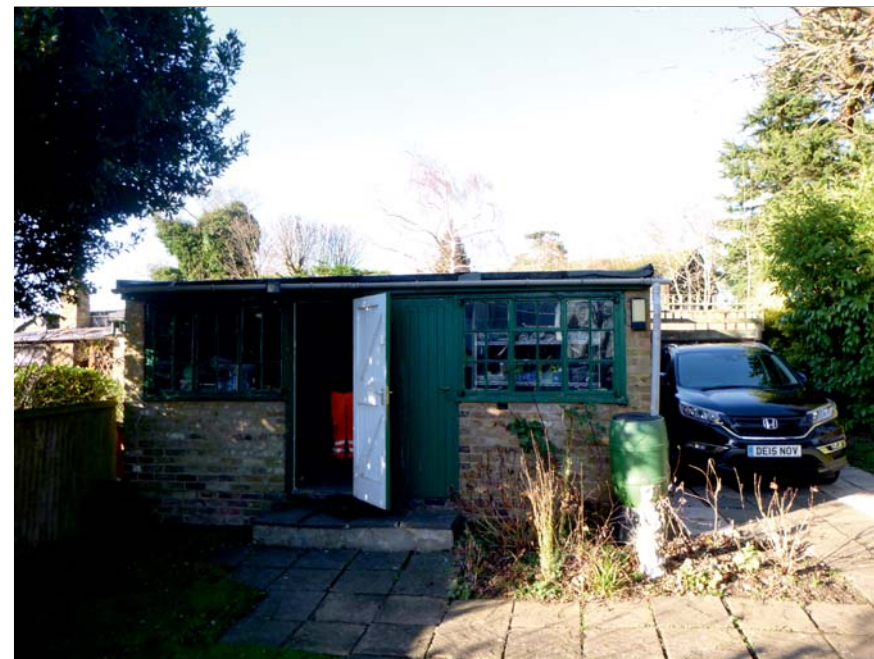
The detached double garage was located at the rear of the plot and accessed via a track off Lockers Park Road. The garage was of masonry construction with a shallow single pitched felted roof. The painted, timber barge boards on the garage were closely fitted, with only narrow gaps visible. There was a timber garden shed within the garden with a pitched felt covered roof and no separate roof space.

Photograph 4: Showing the garage.
